Published in Corrosion 93.

AN EVALUATION OF TITANIUM EXPOSED TO THERMOPHILIC
AND MARINE BIOFILMS

Brenda J. Little, Patricia A. Wagner and Richard I. Ray,
Naval Research Laboratory
Stennis Space Center, MS 39529-5004

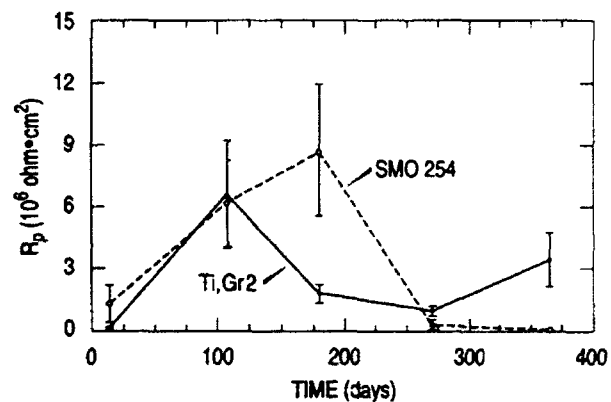
FIGURE 3 – Polarization resistance after exposure to Pacific Ocean seawater

assumption it is easy to understand the decreased ennoblement of titanium (Figure 1) which is a very poor catalyst for the oxygen reduction reaction. This result and the documented resistance of titanium to localized corrosion make it unlikely that localized corrosion will occur in natural seawater under ambient conditions. R_p increased markedly for titanium from day 13 to experiment conclusion, indicating a decrease in corrosion rate (Figure 3). The reverse was true of R_p for SMO 254, i.e., R_p decreased, indicating an increase in corrosion rate (Figure 3). C_{DL} for the metals remained essentially unchanged over the experimental period even though surfaces had been colonized by diatoms and other algae (Figure 4). C_{DL} for titanium was lower than that of the stainless steel and remained close to the theoretical value for the double layer capacitance between 20 and 30 $\mu\text{F}/\text{cm}^2$ (Figure 4), usually observed only for inert metals such as Pt.

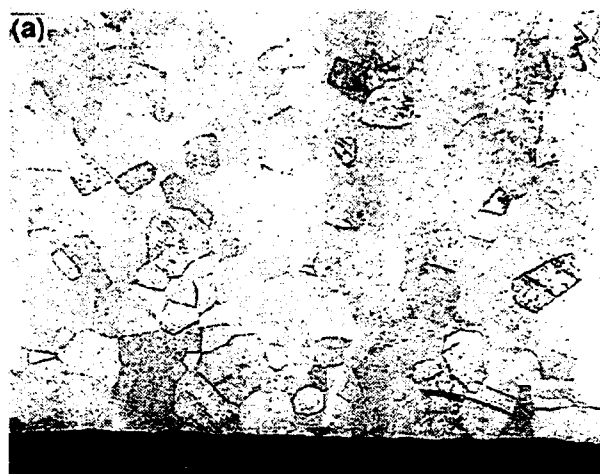
FIGURE 8 – Titanium exposed to *C. saccharolyticum*
(a) base metal and (b) weld

Surfaces of the titanium weld materials exposed to *C. thermosaccharolyticum* were colonized with bacterial cells (Figure 7). Hydrogen analyses results were as follows: unexposed controls—base metal, 36 ppm and weld metal, 37 ppm; exposed—base metal, 45 ppm and weld metal, 37 ppm. Microphotographs of the exposed base and weld samples showed no evidence of hydride formation (Figure 8 a, b). Based on measured hydrogen concentrations there may have been a slight absorption of hydrogen after exposure to the thermophilic hydrogen-producing bacterium. Increased hydrogen after high temperature aqueous exposure may be due to the growth of an oxide film by breakdown of water.
